FAN BLADES RESTORED WITH BELZONA SYSTEM

Geothermal power plant, Indonesia

Fan blades from mechanical draft cooling tower

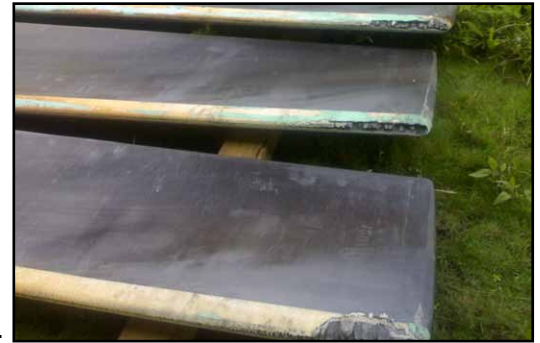
Damage and erosion on the leading edges of the blades reduced the overall efficiency and operation of the cooling system.

1. Damaged cooling tower blades
2. Repair using Belzona® 1111 in progress
3. Belzona® 1341 applied to leading edge of blades
4. Finished repair with Belzona® 5811 applied to blade bodies
