BELZONA KEEPS COURT IN SESSION

Courthouse, Minneapolis, MN

Main air handler fan for cooling system

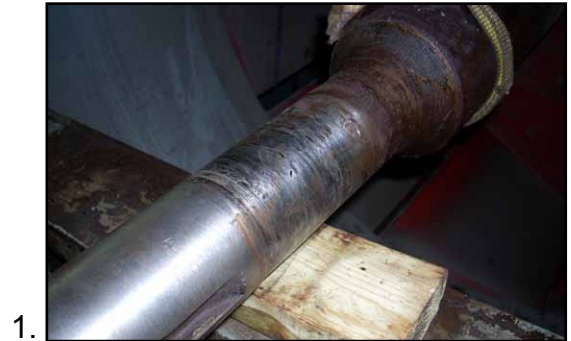
Bearing had failed scoring the 2 1/2 inch shaft. Hot weather required air conditioning to be working effectively.

1. Scored shaft
2. Surface preparation
3. Belzona applied and former secured after treating with Belzona Release Agent
4. Finished shaft with bearing reinstalled
