## BELZONA RESTORES HEAT EXCHANGERS

Hotel, Guaruja, Brazil

Air conditioning plant for the hotel.

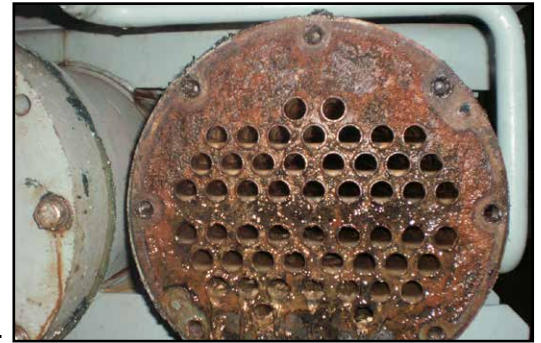
Severe galvanic corrosion on the flange face and tube sheets of heat exchangers.

1. Corroded tube sheet
2. Rebuilding surface with Belzona® 1111
3. Application of Belzona® 1321
4. Final result after removing corks
