BELZONA RESTORES TUBE SHEET PROTECTION

Power station, Cairo, Egypt

Condenser Tube Sheet

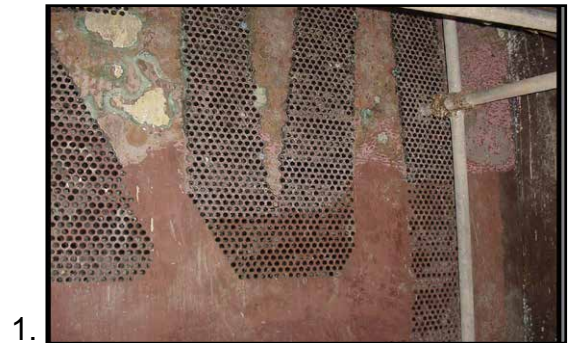
Original coating on tube sheet had failed. Replacement required to prevent future corrosion.

1. Damaged original coating
2. After surface preparation
3. First coat of Belzona® 1321 applied
4. Second coat of Belzona 1321 applied
