BELZONA PROTECTS FAST FERRY BOW THRUSTERS FROM CAVITATION

Bow Thrusters from a 900 Passenger High Speed Service Ferry capable of 38 knots.

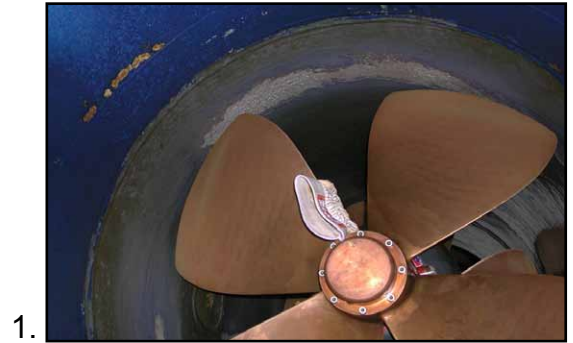
Cavitation problems had manifested themselves in the Port and Starboard Bow Thruster Tunnels. Annual repairs had been attempted with glass flake coatings and Belzona® 1341, but none had been ideal allowing metal loss to continue in the tunnel.

1. Localized damage to Belzona® 1341 (Port)
2. Extensive damage to Glass Flake lining (Starboard)
3. Belzona® 2141 (Portside)
4. Inspection after 5 years service

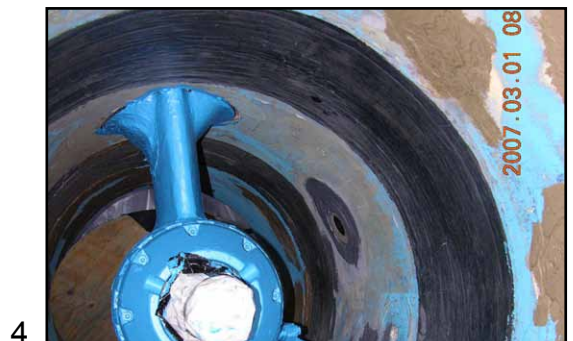
Subsequent annual inspections, most recently in 2007, have shown the Belzona® 2141 to provide outstanding cavitation protection reducing the annual docking cycle from annual to bi-annual for the client. The client is intending to coat the other non-Belzona protected areas as a result.
