BELZONA PROTECTS PLATFORM LEG ABOVE AND BELOW WATERLINE

Offshore production platform, Adriatic Sea

Offshore production platform leg.

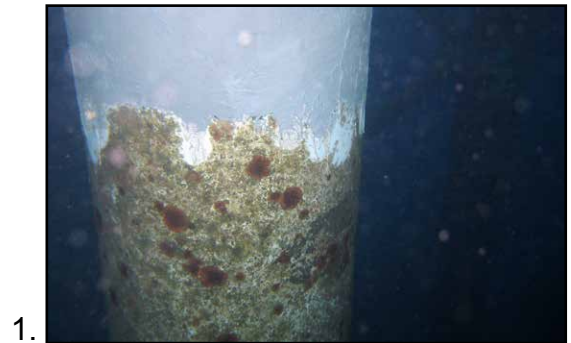
Due to constant immersion in seawater the platform leg in the splash zone was suffering from corrosion and needed protecting.

1. Damage before coating was applied
2. 1st coat of Belzona® 5831 applied
3. 2nd coat of Belzona® 5831 applied below the waterline
4. Completed application above water

Application was carried out in accordance with a modified version of Belzona Know-How System Leaflet SOS-21. After manually preparing the surface the Belzona® 5831 was applied in two coats to the corroded areas above and below the waterline. Application was completed by divers in the water.
