BELZONA PROTECTS COOLING WATER PIPELINE

Power Plant, Croatia

1,65 m diameter Cooling water pipeline

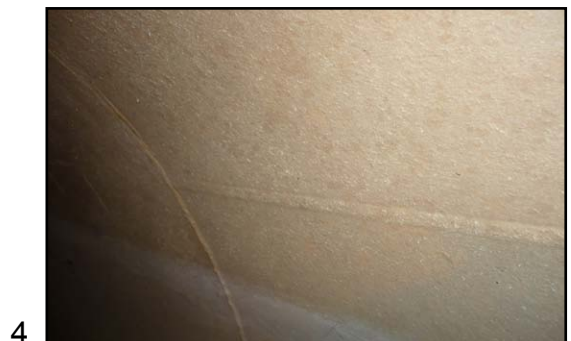
Belzona solvent free system was ideal for application in the confined space. Inspection of the coating after 3 years in service showed no damage at all. Even in 2011 (6 years in service) the coating is still performing well.

1. Corroded inner surface
2. Rebuilding lost profile
3. Belzona® 5811 applied as two coat system
4. Inspection after 3 years showed no damage
