BELZONA PROTECTION OF RISER BEND

Riser bend on offshore platform.

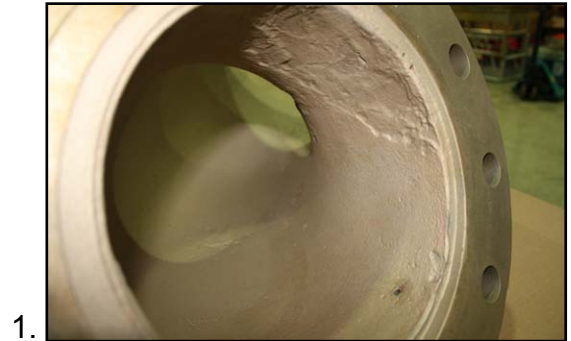
1. Riser bend overview
2. Internal Erosion Corrosion
3. Corroded areas rebuilt with Belzona® 1311
4. Application completed with Belzona® 1321 applied

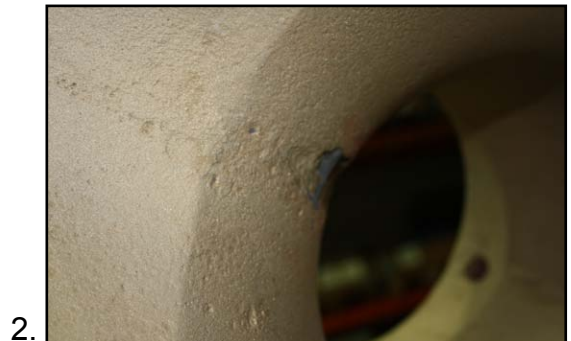
The riser bend was suffering from internal erosion corrosion.
